The Effects of Weather Induced Variables on Large Building Vapor Intrusion Mitigation Systems

Paper # 49

Vapor Intrusion, Remediation, and Site Closure Conference

Thomas E. Hatton,¹ Daniel J. Nuzzetti,¹; ¹Clean Vapor, LLC

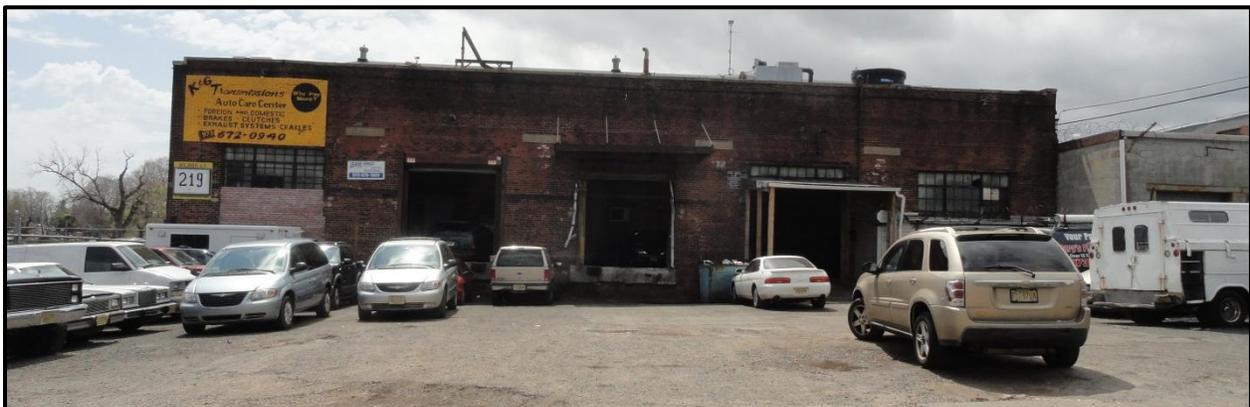
Figure 3

The site area of concern is a former equipment and film manufacturing facility located in northern New Jersey (Figure 3). The building is approximately 66,300 square feet and the area where Contaminants of Concern (COC's) have been identified represents approximately 24,860 square feet. The original main section of the building is estimated to be over 110 years old and is constructed of brick, interior steel columns and a steel truss and wood plank roof. Each of the additions has a different roof elevation that contributes to varying vacuum induced pressure differentials as wind passes over and around the building. Sub slab soil gas surveying and indoor air sampling indicated elevated levels of TCE that were above NJDEP's screening levels for commercial structures.

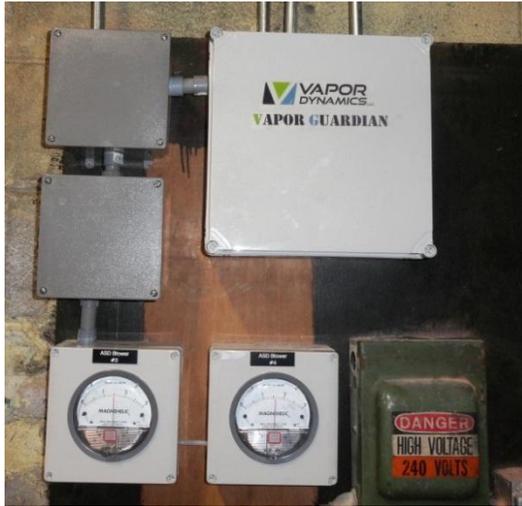
Figure 6

The Vapor Dynamics, LLC Vapor Guardian 5500TM was installed to remotely monitor and dynamically control the mitigation system (See Figure 6). Dynamic controls enable the vapor intrusion mitigation system to maintain a constant predetermined sub slab pressure differential that is set as part of the electronic management and monitoring system. The system monitors the sub slab vacuum levels and self corrects for pressure induced changes that may occur from HVAC operation, exhaust hoods, wind loading and weather induced indoor pressure differentials. The sub slab pressure differential pressure sensor is continually monitored by a programmable logic controller (PLC) which controls the variable frequency drive (VFD) to adjust the blower speed to maintain the predetermined sub slab vacuum set point. Time dampening to prevent harmonic responses that are induced by wind gusts were instituted as part

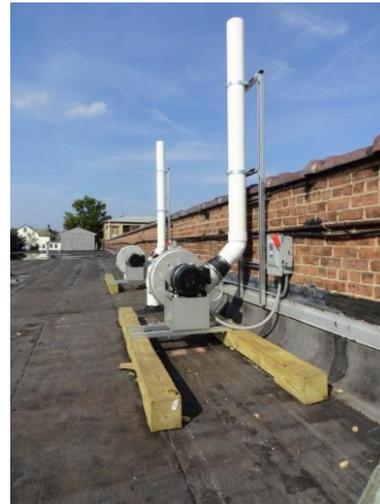
of the startup procedures. Additionally, the PLC packets the data and outputs to a remote client login through a wireless cradle point. Two of the four blowers installed at this site feature the dynamic controls software; all four of the blowers are remotely monitored. The data is also stored for system analysis and regulatory reporting. Figure 7 shows the roof mounted blower systems.

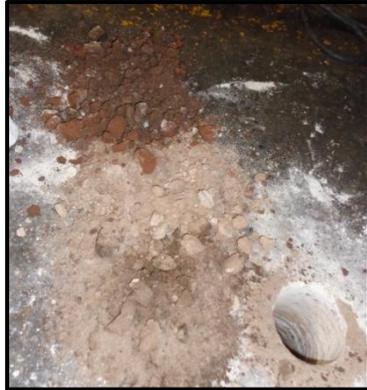
Figure 18

Monitoring data from a nearby site where a dynamically controlled sub slab depressurization system is running was accessed for the purpose of comparing low and high permeable fill types. The major difference between the two sites is that the second site has a 4 to 6 inch crushed stone layer below the slab as opposed to the native soils found at first site. The second site is a manufacturing plant where high airflow fume hoods cycle on and off during production resulting in the interior of the building being subject to greater pressure fluctuation. Excess motor capacity was built into the design at the nearby site to accommodate including another section of the building on the same motor. Figures 18 shows the native soil from the first case study site and Figure 19 shows the crushed stone from the nearby site.
